ROUND VALLEY SOUTH DAM

PHASE I INSPECTION REPORT

NATIONAL DAM SAFETY PROGRAM

NJ 00015

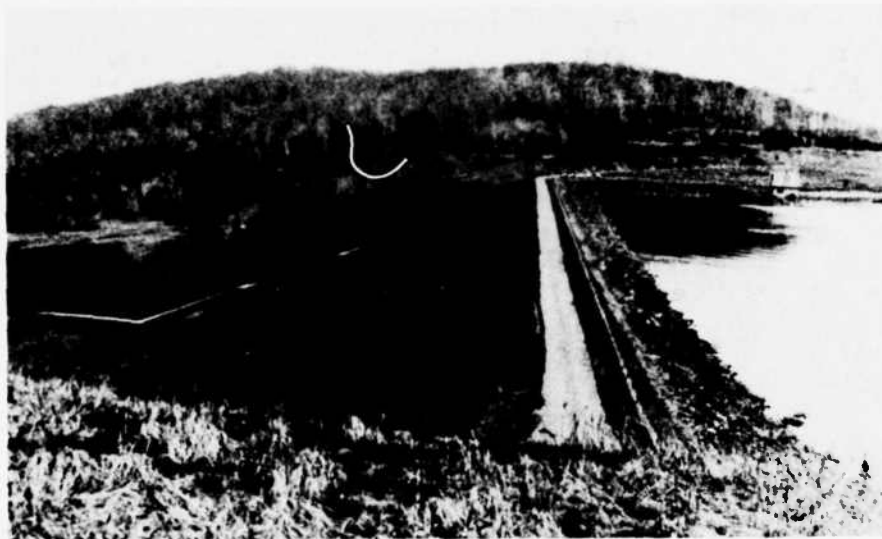
OVERALL VIEW OF DAM

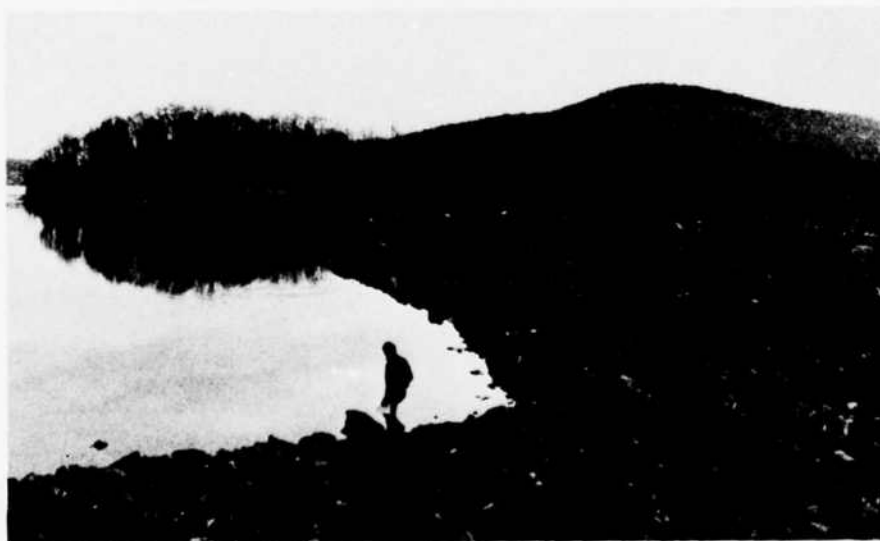
UPSTREAM FACE OF DAM

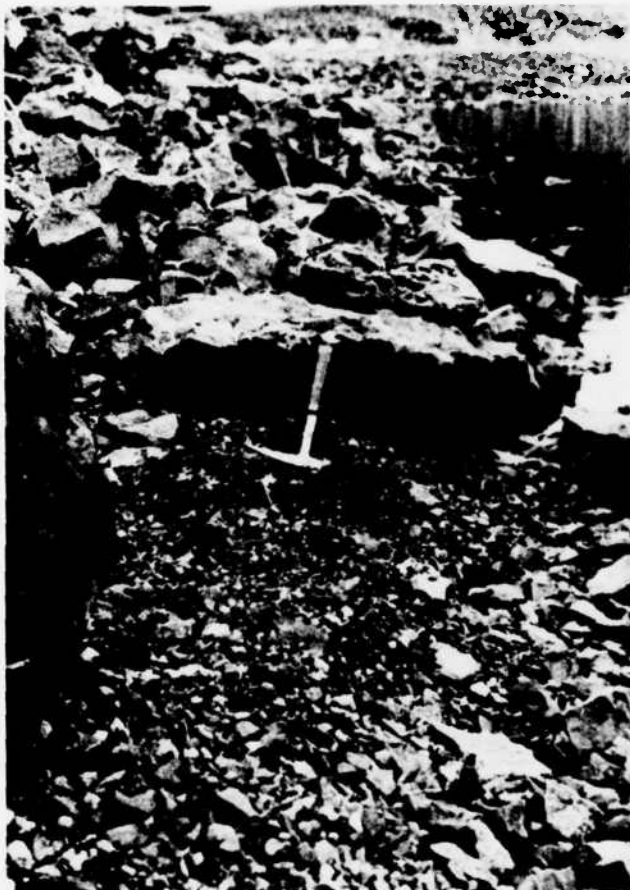
The riprap on the upstream slope is poorly graded and inadequate to provide the necessary protection against erosion due to wave action. The riprap stone appears to have been susceptible to stress release or frost-wedging against fracture planes. According to Mr. Chase, considerable deterioration of the rock has occurred since its placement at the time of construction. Subsequent wave action has left portions of the embankment unprotected.

VIEW OF RIP RAPPED SLOPE
SHOWING POOR GRADATION

Inspection of the rock riprap, used for the upstream slope protection, revealed signs of rock size segregation and material deterioration. The riprap should be supplemented to provide a well graded, protective layer.

(1) The upstream slope protection should be repaired to provide a suitable well graded riprap layer.

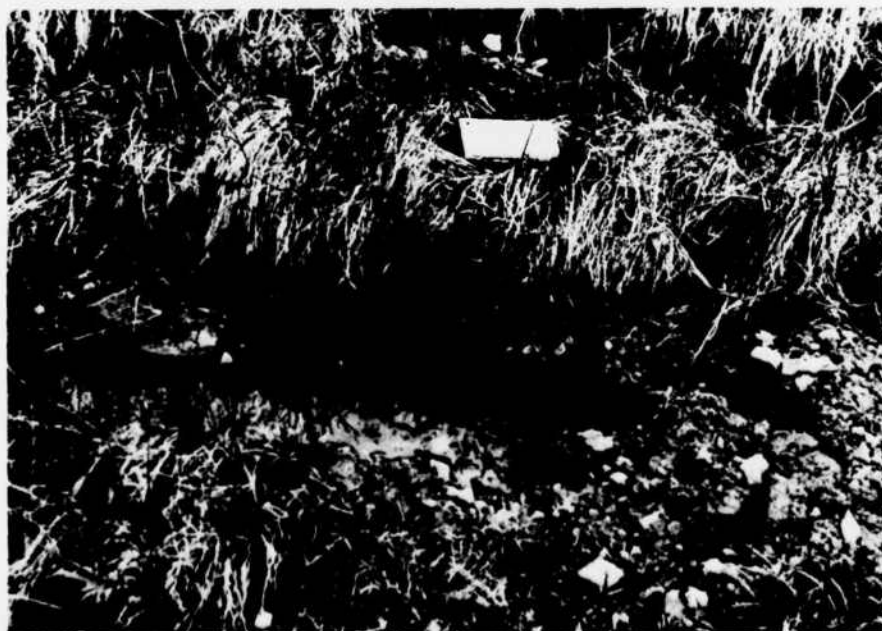
Standing water was noted along the third or lower berm and in tracks or furrows that were, according to Mr. Gregory Chase, made by the equipment used to cut the grass on the downstream slope. The amount of seepage or standing water was significant at the east end of the embankment; below the third or lower berm, the condition of the grass and topsoil indicated a very moist or wet condition. Below the riprap, observed at the base of the random fill, water is discharging from the embankment or foundation. The discharge is estimated at about one cubic foot per second.

The South Dam embankment appears to be stable. However, the signs of moisture and wetness on the downstream slope, especially at the lower third of the east side, indicate that the phreatic line may intersect the embankment slope at a point well above the filter blanket or rock toe. However, it is possible that the rainfall that occurred previous to the inspection may have been partially responsible for this condition. Since there are no piezometers installed in the embankment, the magnitude of pore pressures cannot be assessed.

STANDING WATER ABOVE BOTTOM BERM NEAR
EAST ABUTMENT

a. Installation of piezometers should be initiated within one month from the date of approval of this report and a new stability analysis performed if the readings differ significantly from the design assumptions. In addition, the embankment should be monitored continuously for signs of increased seepage and/or turbid water.

The embankment of the South Dam should be monitored continuously for signs of increased seepage rates and/or turbid water.
